**SHETUCKET RIVER BASIN
NORWICH, CONNECTICUT**

**SPAULDING POND BROOK
SITE NO. 2**

**DIKE CT 01712
DAM CT 00203**

**PHASE 1 INSPECTION REPORT
NATIONAL DAM INSPECTION PROGRAM**

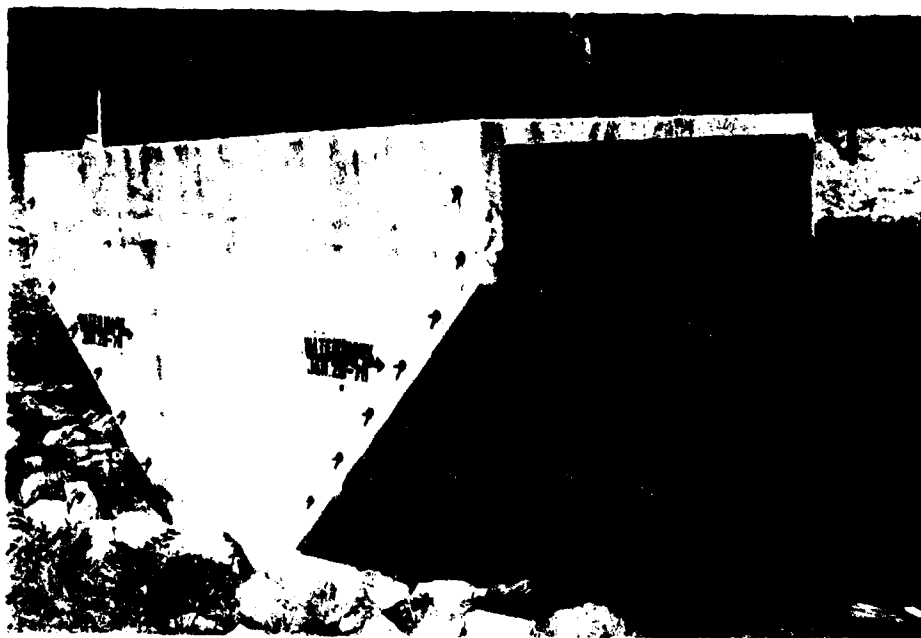
1. Drop Inlet Spillway: The concrete structure and the trash racks are in good condition (Photo 4). There is a gate controlling a low-level inlet on the upstream face of the concrete structure (Photo 4). At the time of inspection, the gate was partially open. The outlet pipe discharges into a riprap-lined channel (Photo 7). There is some brush growing in the channel which may present some obstruction to the flow.

Photo 4. Drop inlet primary spillway structure. Note grate for pipe inlet on upstream side.
